# AEROSPACE INFORMATION REPORT

AIR1707

## Patterns of O-ring Failures

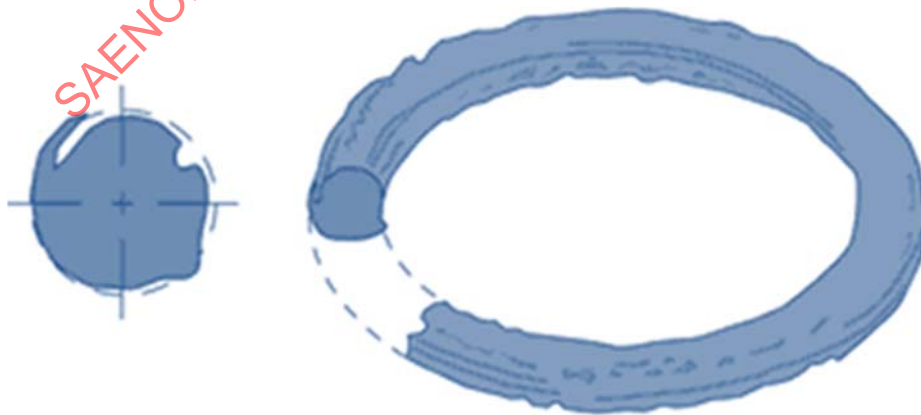
Exhibits many small nibbles removed from the O-ring adjacent to the downstream clearance area, or a small section of the O-ring may be extruded. Typical of high pressure systems, this process sometimes erodes half of the O-ring cross-section before major leakage occurs.

Clearance is too large, pressure is too high, O-ring is too soft, O-ring is softened and swelled by fluid, clearance increases under pressure, eccentricity causes irregular gap, and corners of O-ring gland are too sharp.

FIGURE 1 - EXTRUSION AND NIBBLING

Closer metal fits (reduce diametral clearance or reduce plate gap,) use of backup rings or other antiextrusion devices such as cap strips, harder O-ring material, use of O-ring more compatible with system fluid, more rigid or concentric metal components, and break edges of gland to a radius of about 0.001 to 0.002 inch (0.025 to 0.050 mm). T-seals that fit into the same gland may also be substituted.

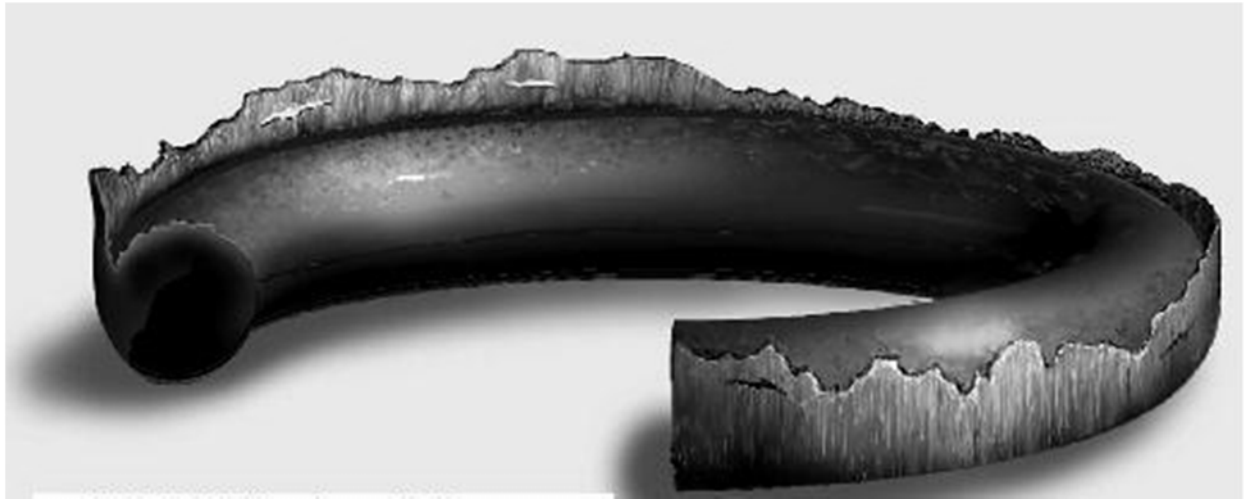
FIGURE 2 - EXTRUSION AND NIBBLING (USED WITH PERMISSION FROM R.L. HUDSON)

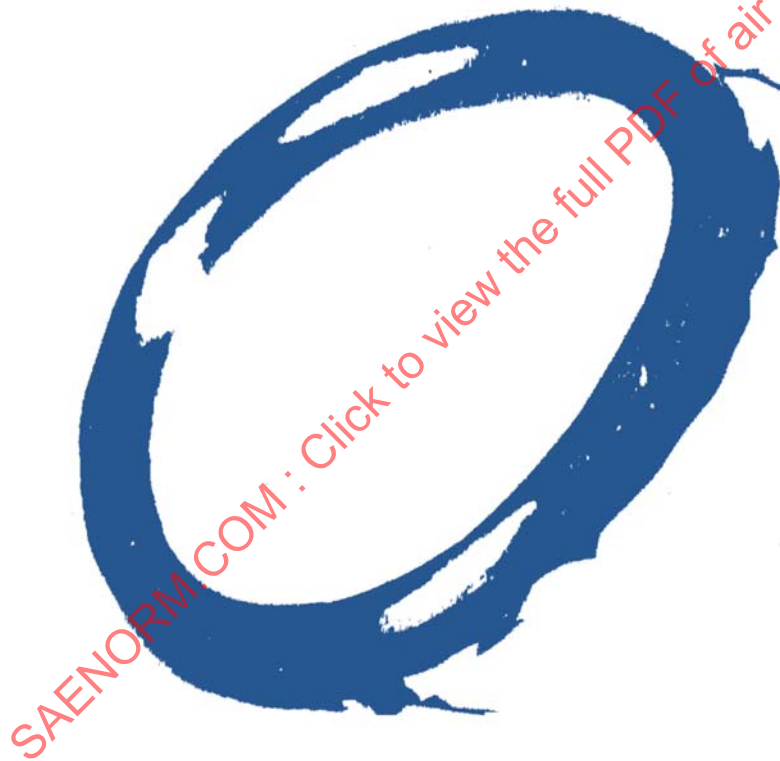
FIGURE 3 - NIBBLING AND SKIVING

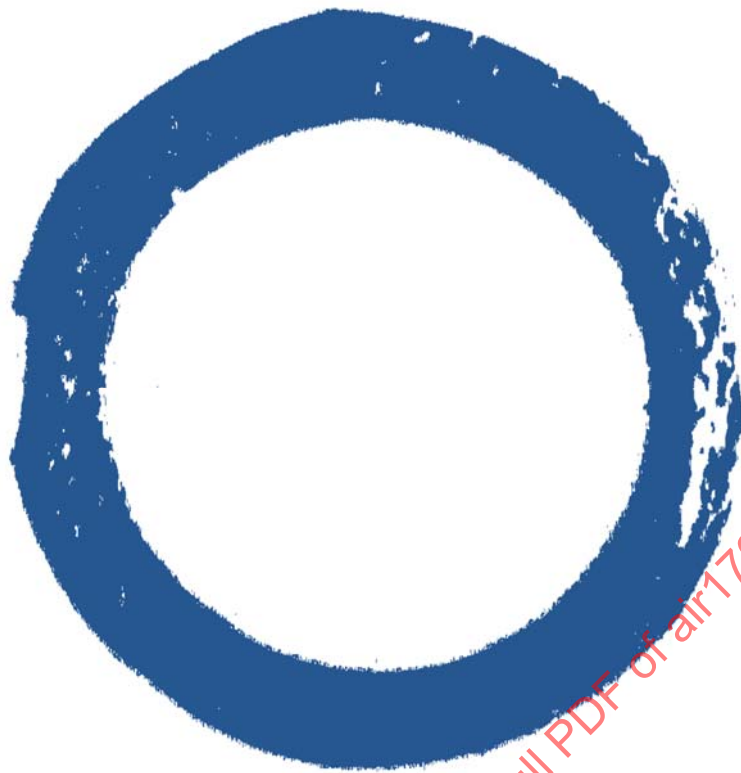
FIGURE 4 - NIBBLING AND ABRADING

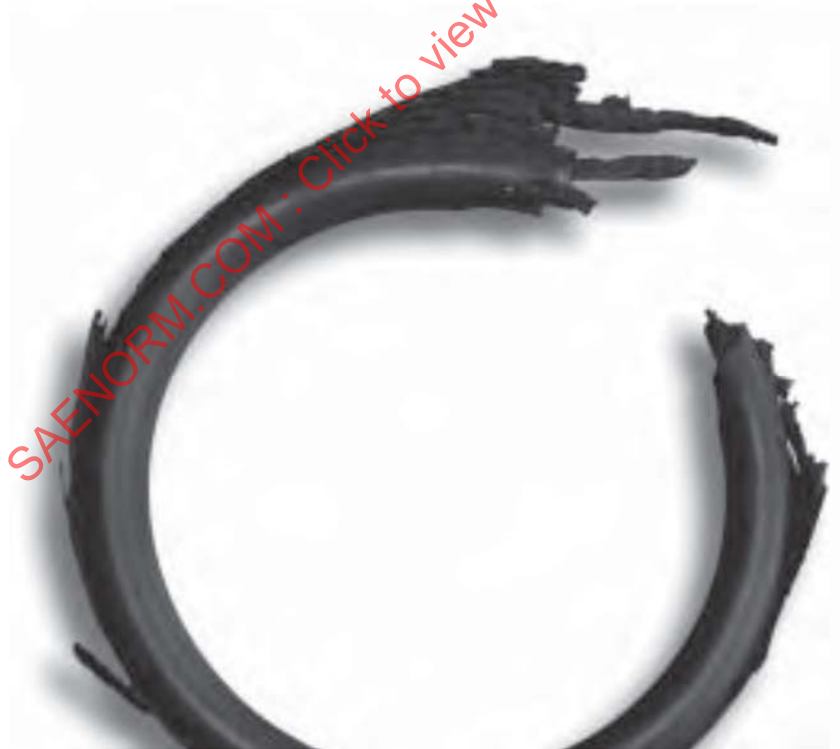
FIGURE 5 - NIBBLING AND EXTRUSION

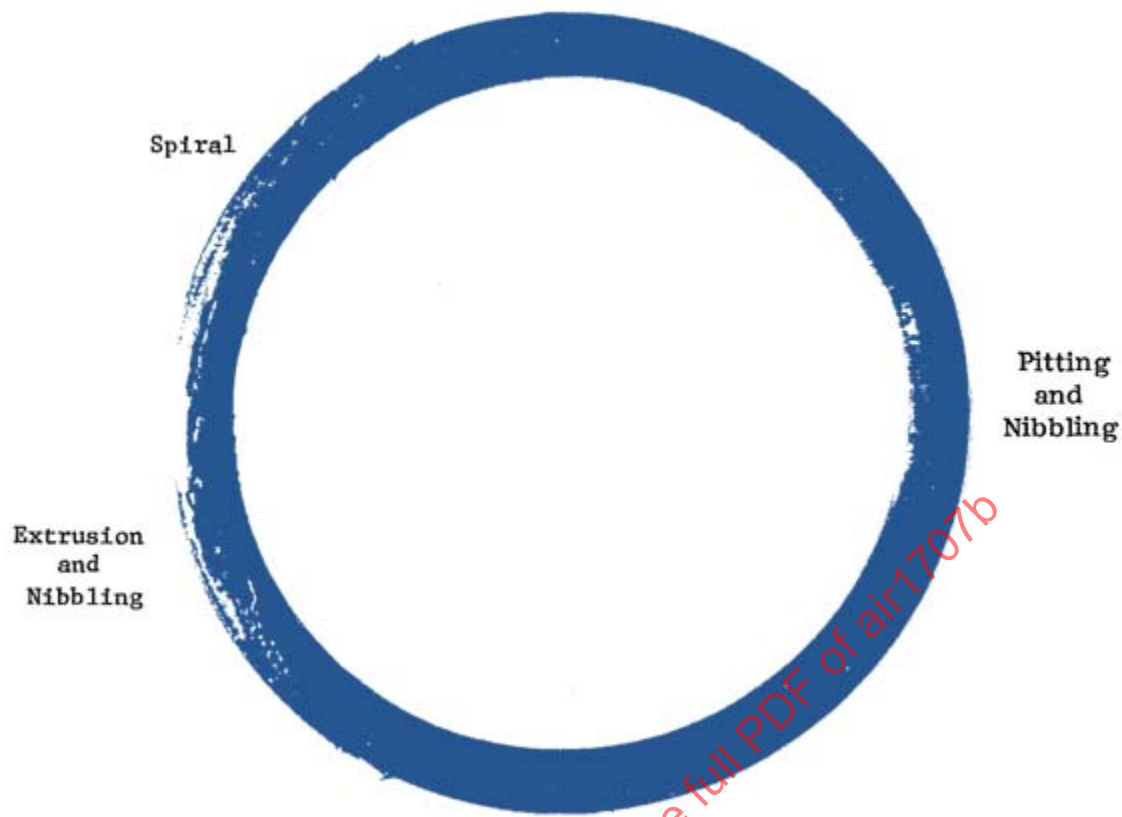
FIGURE 6 - NIBBLING, EXTRUSION, PITTING, AND SPIRAL FAILURE

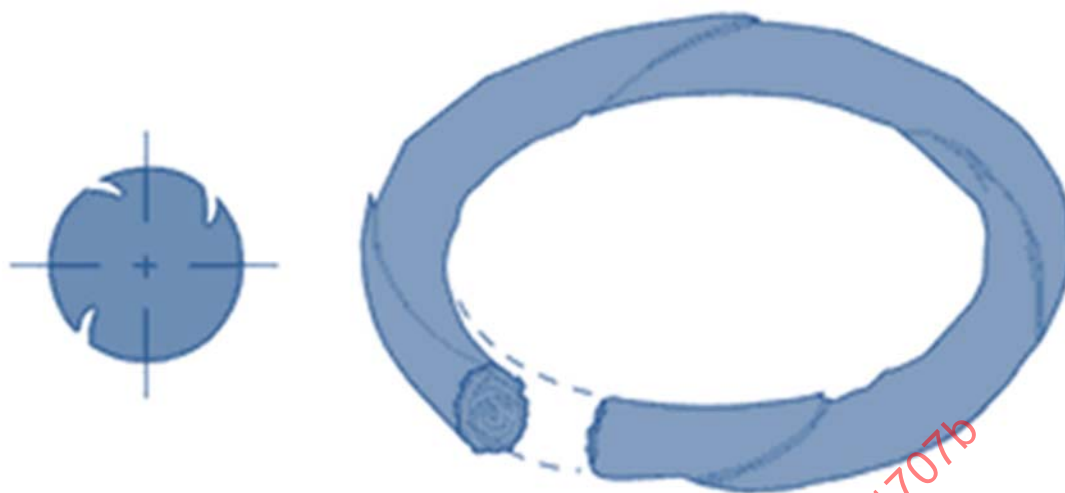
Exhibits a deep spiral cut (usually at about 45 degree) into the O-ring cross-section.

Conditions which cause segments of the O-ring to slide and others to roll, simultaneously. The O-ring generally gets pinched or "hung up" at one point of its periphery. Side loads causing the O-ring to get caught in an eccentric component, uneven surface finishes, poor or uneven dispersion of lubricant and stroke speeds contribute.

FIGURE 7 - SPIRAL FAILURE

Improve metal surface finish to the 10 to 20 microinches (0.25 to 0.50  $\mu\text{m}$ ) range, improve lubrication, use backups or other antiextrusion devices if possible, reduce gap, and consider seals other than O-rings such as T-seals.

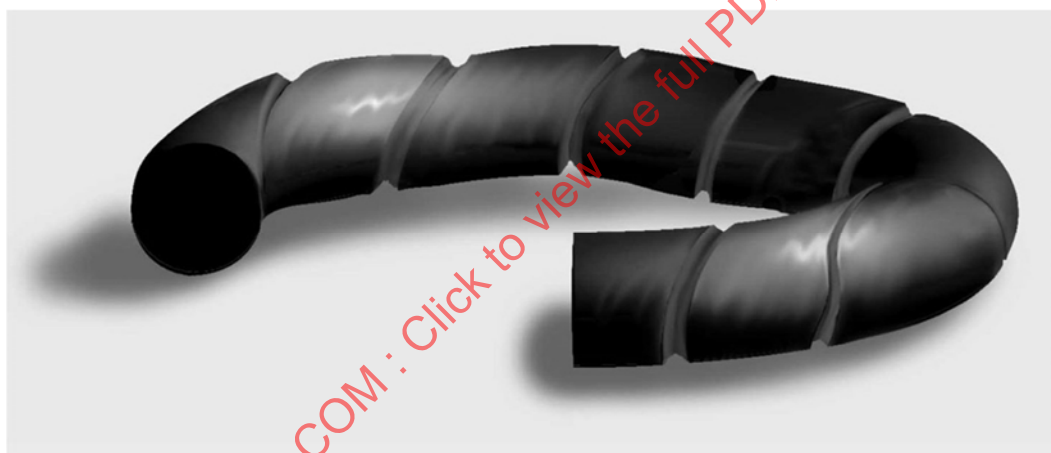
FIGURE 8 - SPIRAL FAILURE (USED WITH PERMISSION FROM R.L. HUDSON)

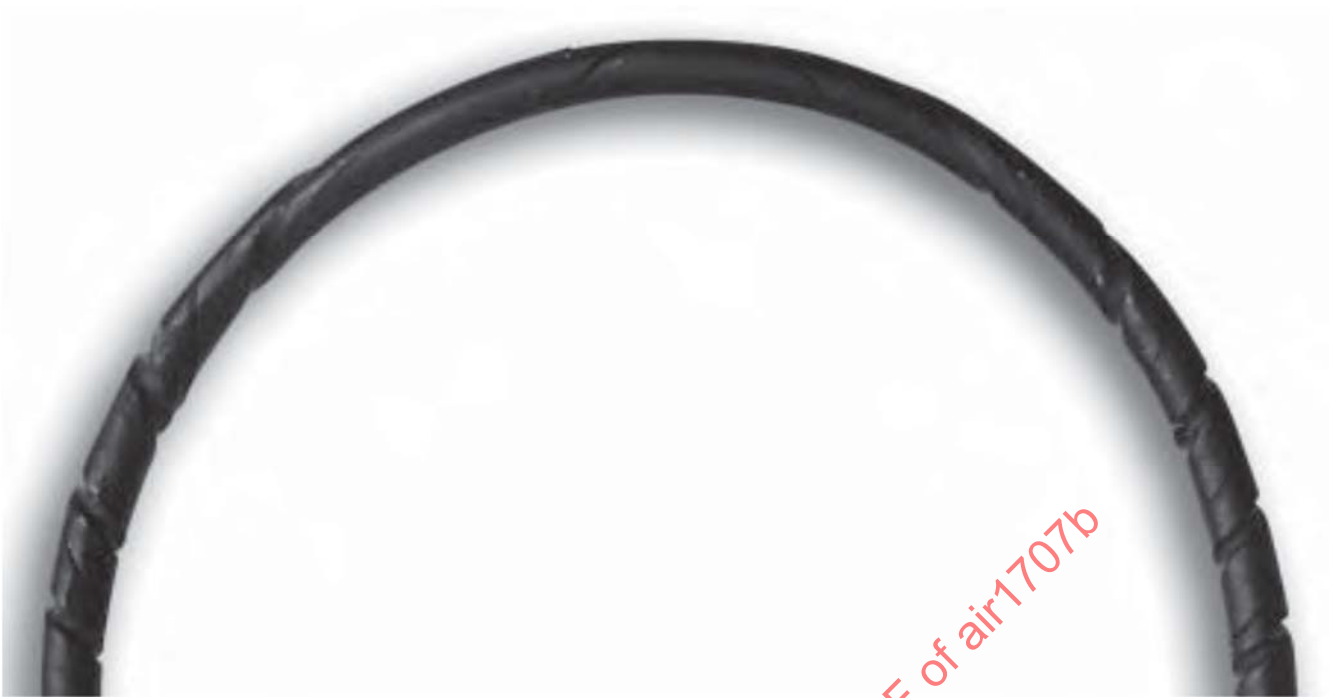
FIGURE 9 - SPIRAL FAILURE (PHOTO COURTESY OF PARKER HANNIFIN)

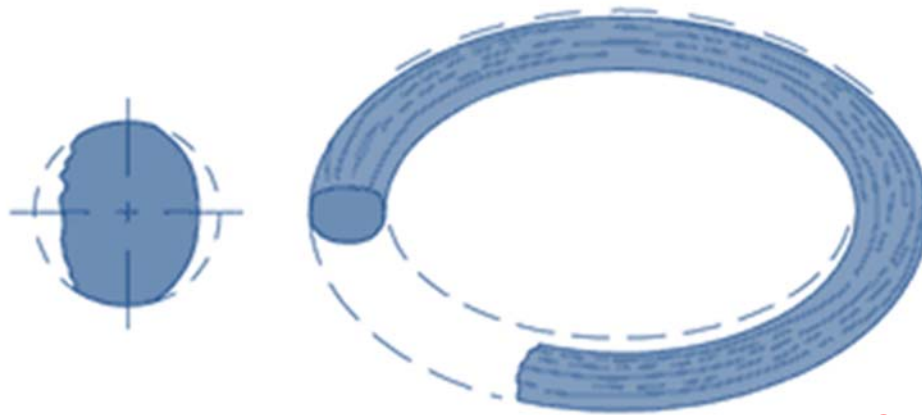
Flat area on one side of cross-section of O-ring where moving contact is made with metal component. Frequently shows wear lines on the cross-section parallel to motion of the seal.

Too rough or too smooth metal surfaces, poor lubrication, high temperatures, or fluid contamination.

FIGURE 10 - ABRASION

Use recommended metal finishes, provide adequate lubrication, use O-ring material compatible with service temperature, and eliminate fluid contamination. Rapid wear can be expected with finishes below 5 microinches (0.13  $\mu\text{m}$ ).

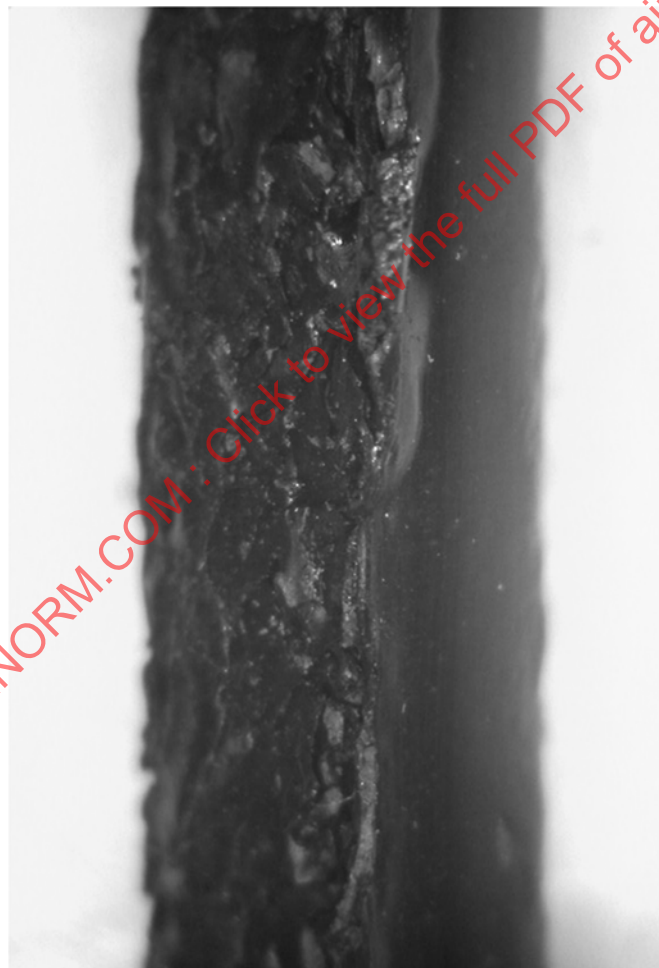
FIGURE 11 - ABRASION ON ONE SIDE

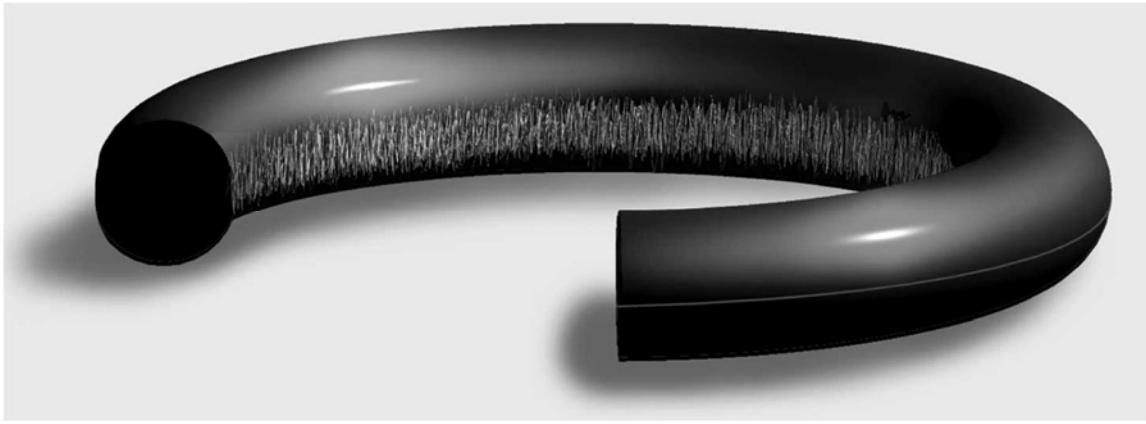
FIGURE 12 - ABRASION (USED WITH PERMISSION FROM R.L. HUDSON)

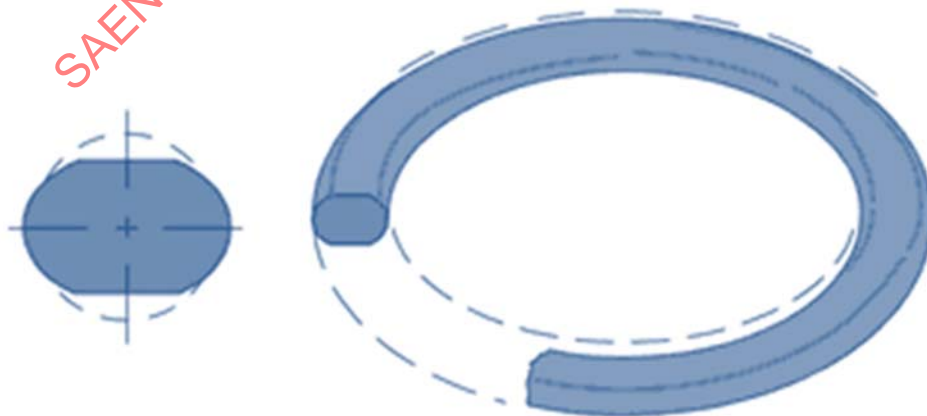
Flat area on both sides of O-ring cross-section in the area being squeezed.

Temperature too high (either environmental or frictional) causing hardening, excessive volume increase from fluid causing overfill, excessive squeeze to achieve seal, O-rings not completely vulcanized, or use of compound with poor set properties. In extremely rare cases, this can also be caused if a ring is over-cured (reversion.)

FIGURE 13 - COMPRESSION SET

Use O-ring material compatible with fluid and temperature service, minimize conditions which increase service temperature, review squeeze to be sure it is proper, and use an improved, low-set compound if available. A good quality, well-inspected O-ring is important.

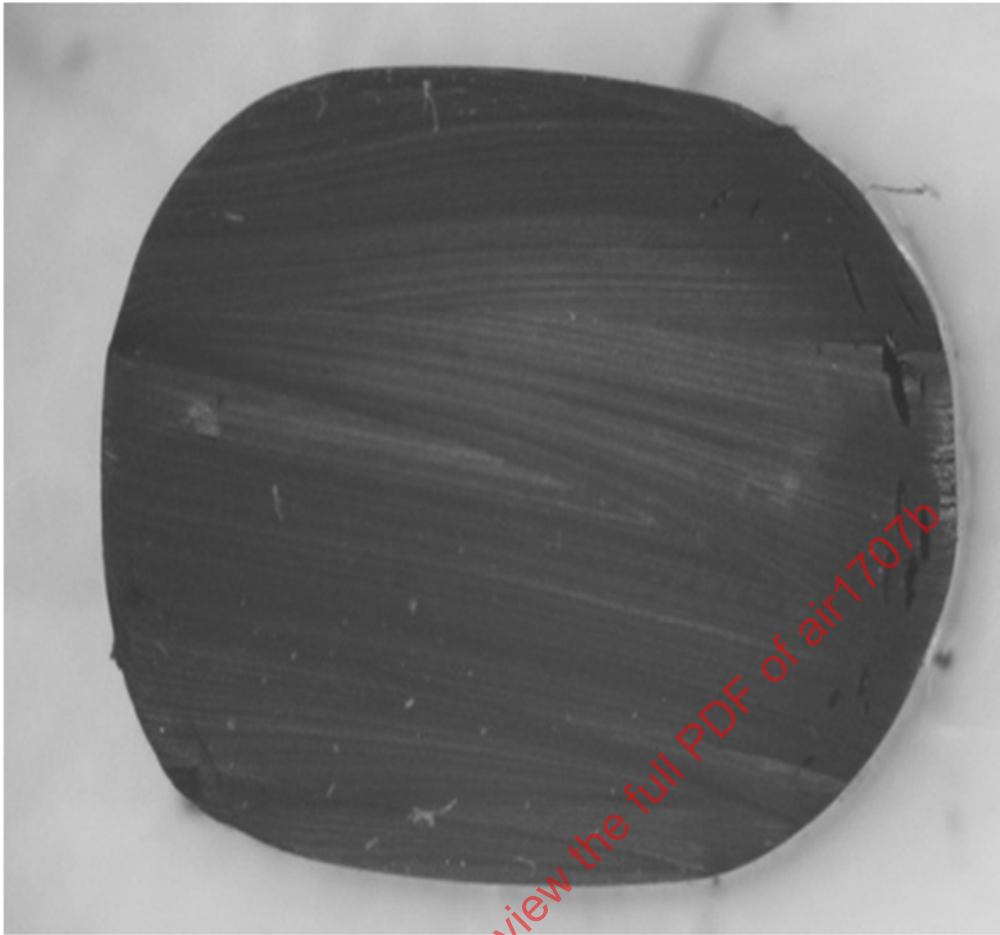
FIGURE 14 - COMPRESSION SET ON THREE SIDES (CROSS-SECTION)

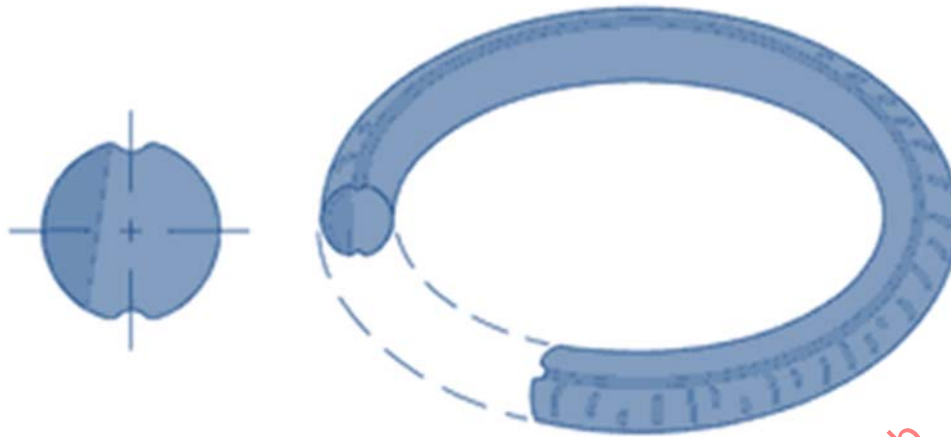
Many small cracks perpendicular to the direction of stress may be small enough to be unseen with unaided eye or large enough to progress entirely through the cross-section (also see 4.8.3). Cracking of the outside surface of the O-ring is the most common.

Ozone attacks unsaturated or double bond points in polymer chain of some polymers causing chain scission. The damage is usually seen on the outside surface, exposed to the atmosphere.

FIGURE 15 - WEATHER OR OZONE CRACKING

If conditions of service cannot be remedied, the rubber material must be changed. Use rubber materials that are saturated and inherently resistant to ozone attack. Change storage conditions to reduce exposure time to detrimental environment. Sufficient improvement can, at times, be obtained by using rubber compounds with antiozonant additives.

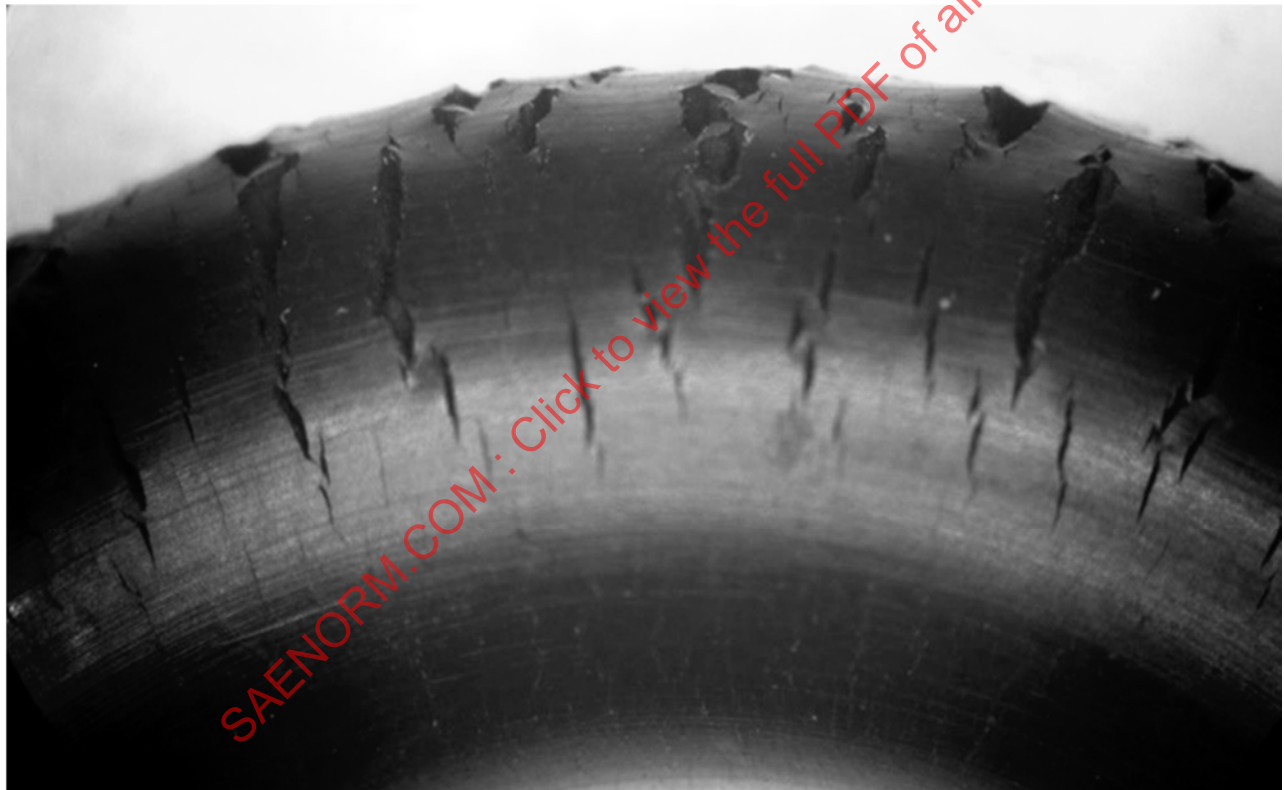
FIGURE 16 - CRACKING FROM OZONE

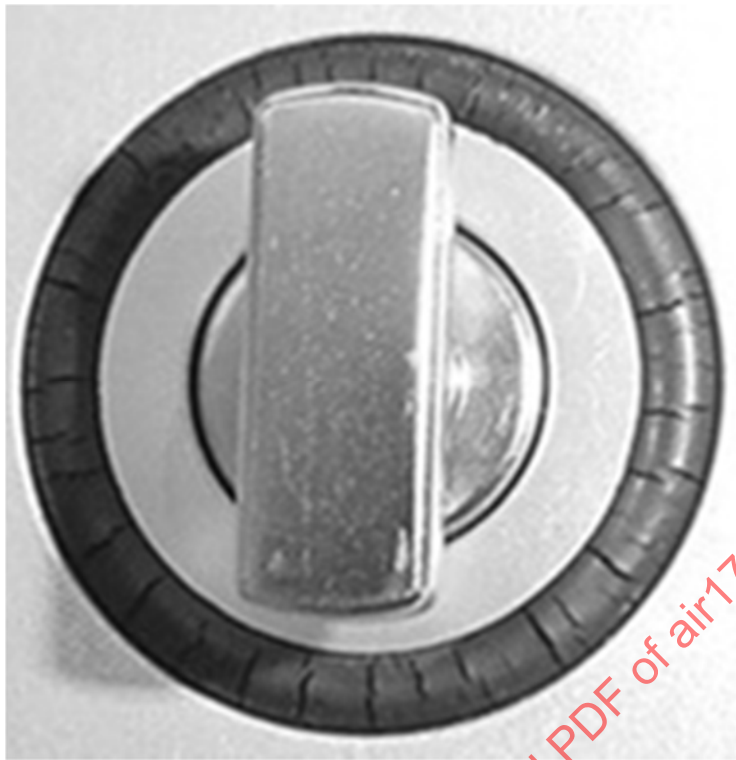
FIGURE 17 - CRACKING FROM OZONE

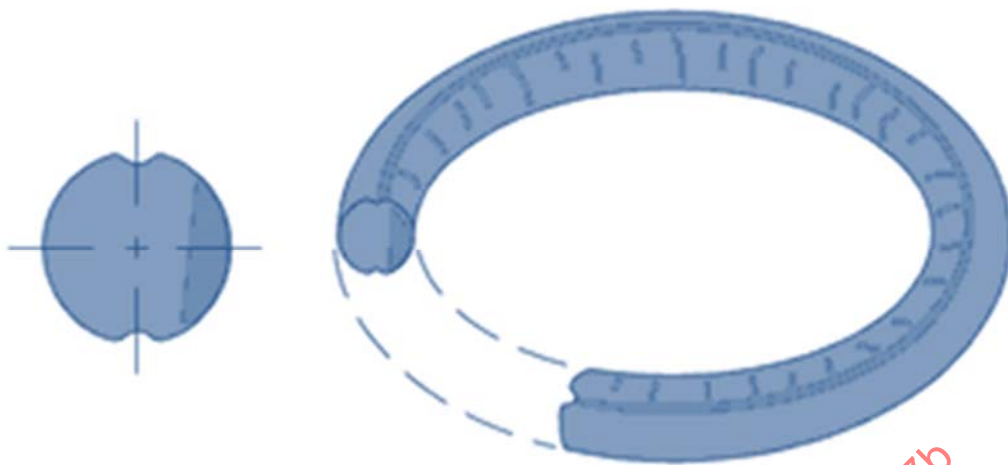
Hardening of the rubber begins at the surface and progresses through the entire O-ring cross-section. Hardening is accompanied by high compression set if O-ring is under compression.

Environmental temperature and oxygen exposure are too high for the selected rubber material, causing hardening due to additional cross-linking in the rubber, evaporation of rubber plasticizer, or oxidation. It may be a combination of these.

FIGURE 18 - HARDENING AND OXIDATION

Decrease service temperature, select a rubber material with better resistance to high-temperature and/or oxygen exposure, or protect surface from oxygen exposure (as wiper seals).

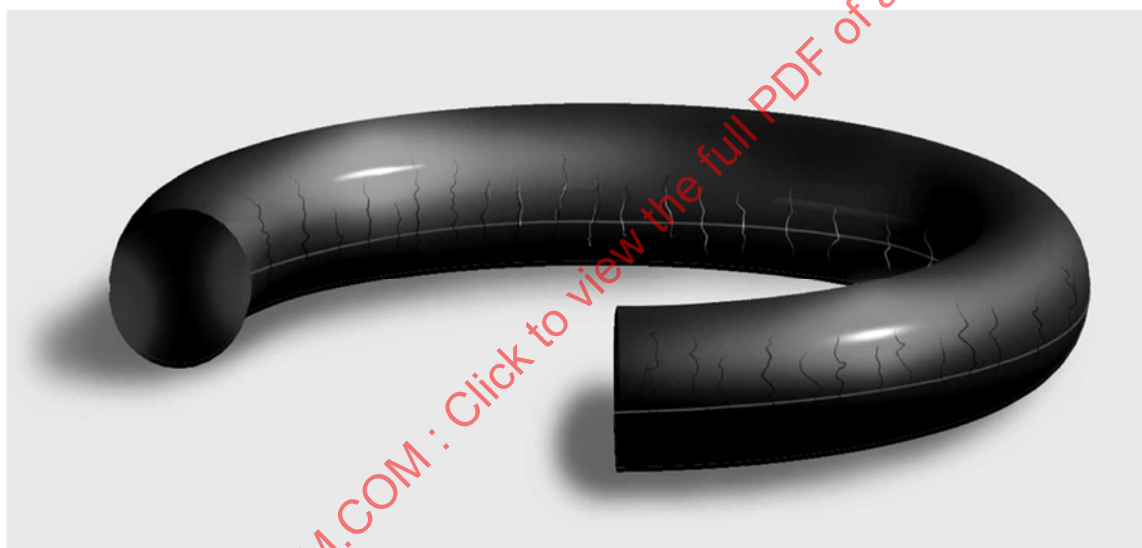
FIGURE 19 - WEATHER CRACKING (USED WITH PERMISSION FROM R.L. HUDSON)

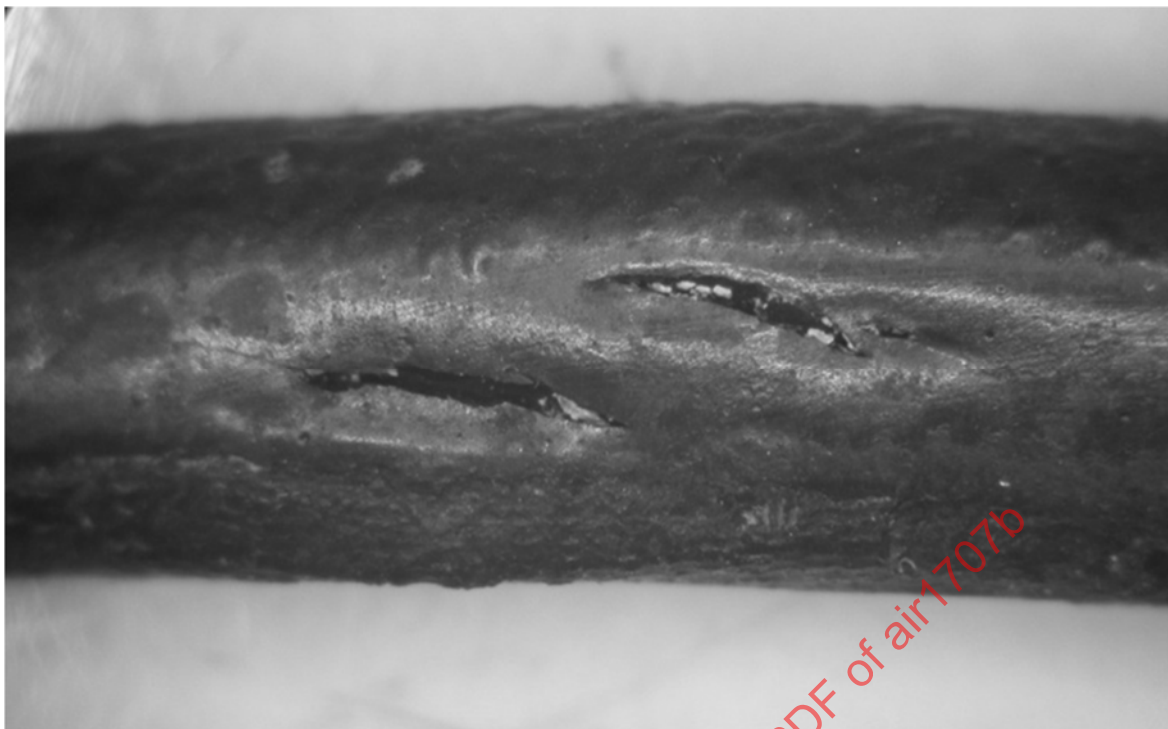
FIGURE 20 - HARDENING AND PITTING

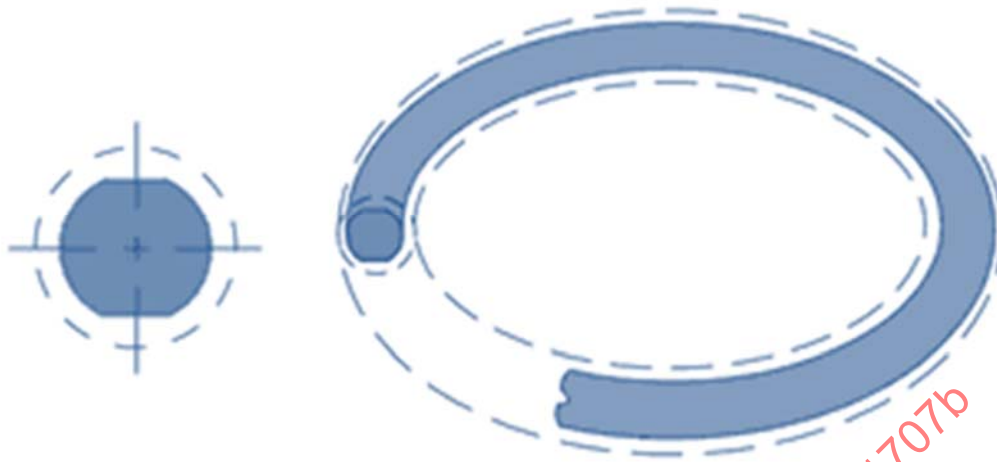
Small cracks in stressed area of O-ring cross-section, accompanied by loss in volume. This is often difficult to detect with a visual inspection.

Extraction of plasticizer by service fluid followed by evaporation of service fluid during dry-out period. Results are hardening of the rubber material and decrease in elongation to the extent that cracks appear where stressed. This condition is accelerated in the presence of ozone.

FIGURE 21 - PLASTICIZER EXTRACTION

Assuming service conditions cannot be improved, change to a compatible rubber material with low or no extractable plasticizer content.

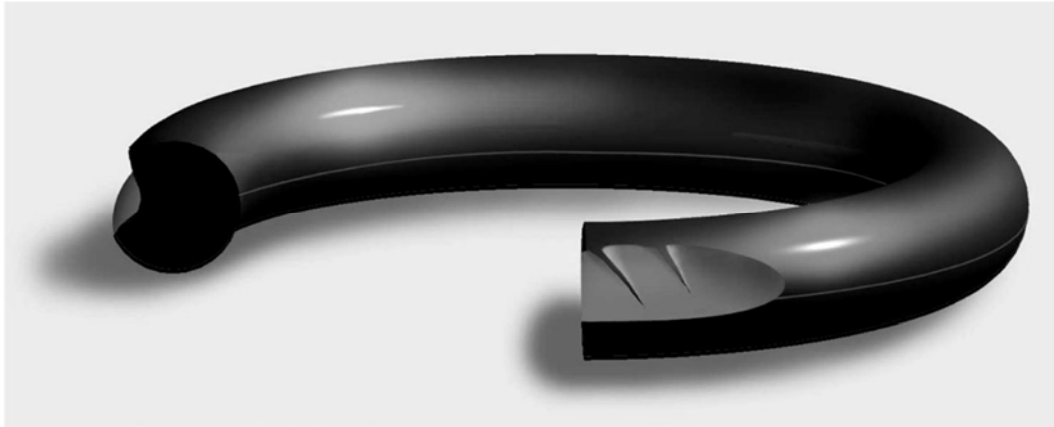
Short cuts or notches or a "shinned" surface or a "skived" cut that can extend at a uniform thickness clear around the periphery of the O-ring and can continue through the cross-section as if it were being peeled. May also present as spiraling or twisting in certain applications.

Sharp corners on mating metal parts, threads, or insufficient lead-in chamfer; inside diameter of O-ring too small on rod seal or too large on piston seal installation. Blind grooves in multiple port valves are especially troublesome.

FIGURE 22 - INSTALLATION DAMAGE (USED WITH PERMISSION FROM R.L. HUDSON)

Adjust dimensions of metal components and O-rings to eliminate cutting or pinching of seals when possible. Lead-in chamfers should be 20 degrees maximum and "break" sharp corners of chamfer and groove edges. Use tubular installation tools to cover threads and sharp corners during O-ring installation. If feasible in the application, use an elastomer that is more resistant to mechanical damage (e.g., EPDM instead of silicone).

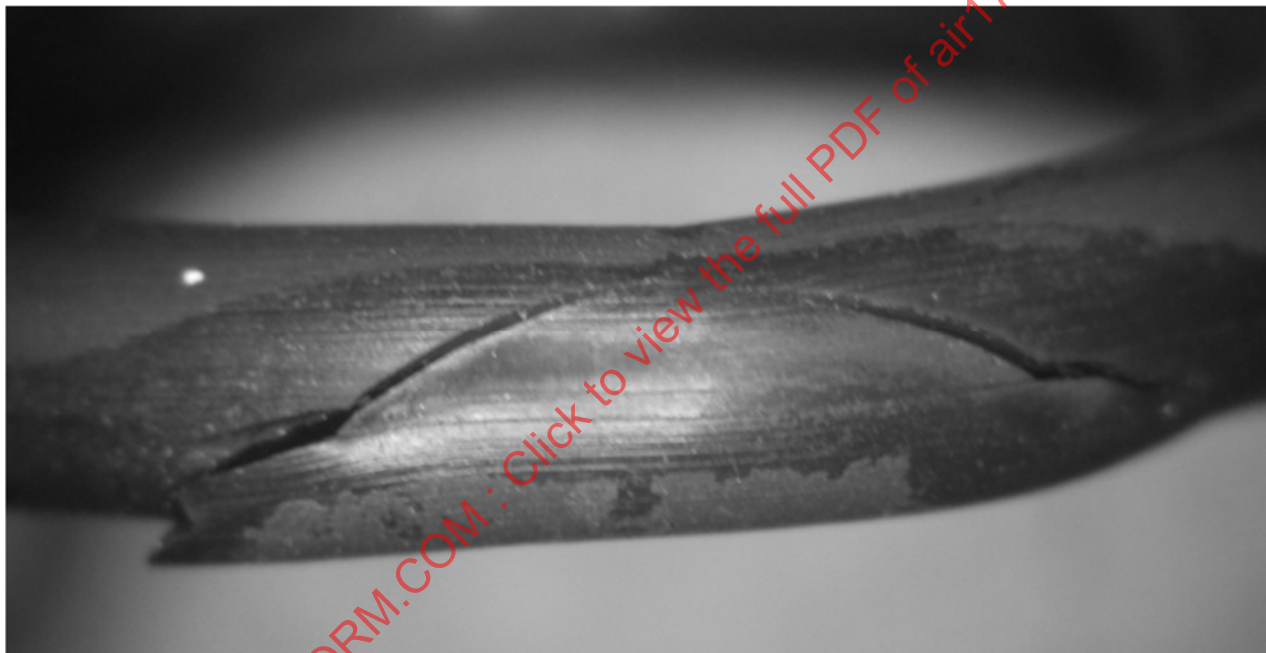
FIGURE 23 - TWISTED AND PUNCTURED INSTALLATION DAMAGE

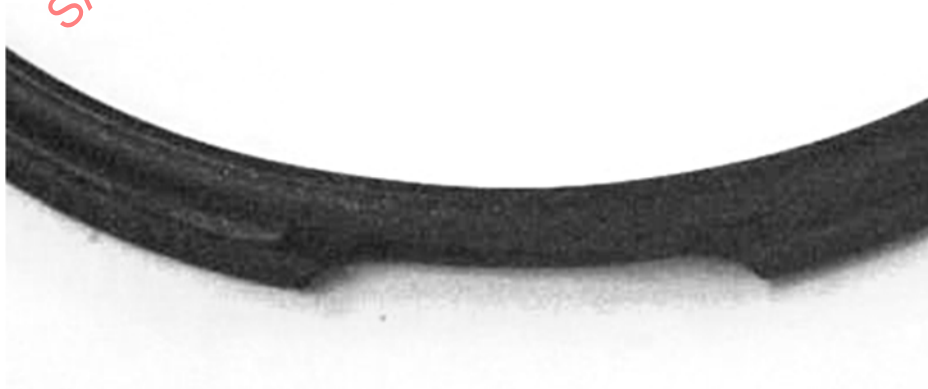
FIGURE 24 - SKIVED INSTALLATION DAMAGE
