# NFPA 909

## Code for the Protection of Cultural Resources

### 2001 Edition

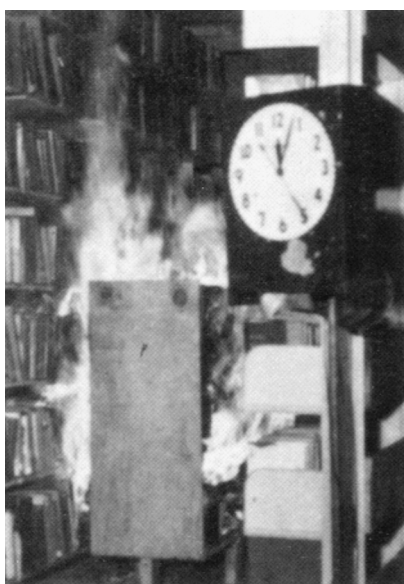
**FIGURE J.2(c)** Three minutes, 25 seconds; active burning in first tier; sprinklers not yet operating.

In this test, one sprinkler opened in the second tier at 3 minutes, 43 seconds after the fire was lighted and one sprinkler opened in the first tier 7 minutes, 53 seconds after the start. The sprinkler discharge stopped the spread of fire in the books almost immediately and gradually extinguished the fire.

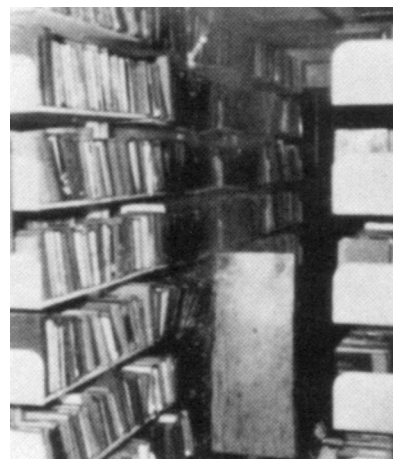
**FIGURE J.2(e)** After fire extinguishment by sprinklers; fire damage to books in only 10 percent of space.

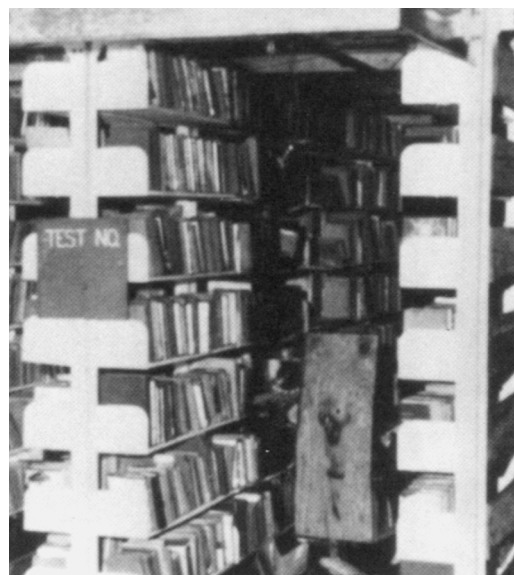
**FIGURE J.2(f)** Close-up of extent of fire damage after Test 1 with automatic sprinklers. Note limited area of fire damage.

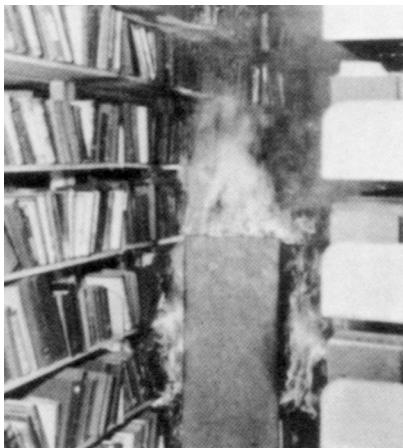
**FIGURE J.3(b)** After approximately 3 minutes; active burning in first tier; no sprinklers.

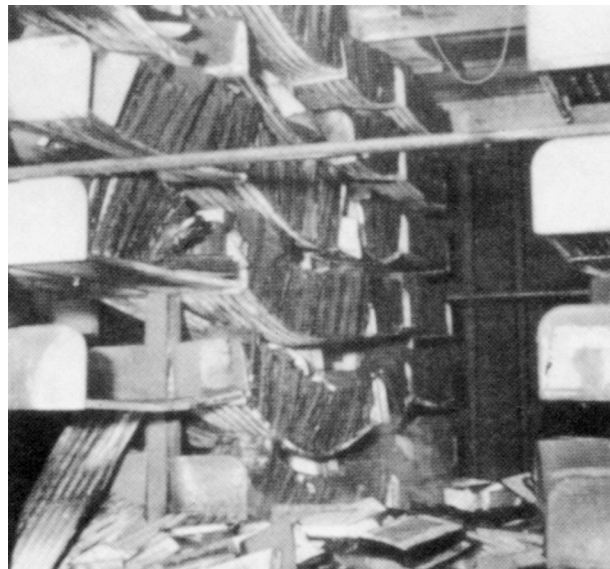
**FIGURE J.3(g)** Extent of damage to shelving after Test 2 (no sprinklers) on second tier, right aisle. Note severe charring of books and collapse of shelving.

Some indication of the extent of the damage to the books and stacks is given by the photographs in Figures J.3(e) through J.3(g). Quantitatively, 89 percent of the books were charred deeply or completely destroyed,  $2\frac{1}{2}$  percent were scorched, and the remaining  $8\frac{1}{2}$  percent were soaked.
